# Claxton Walker & Associates

## Property Inspection Report

**Inspection Site:** 1000 Main St.  
Anywhere MD 12345

**Prepared for:** Harry Homebuyer

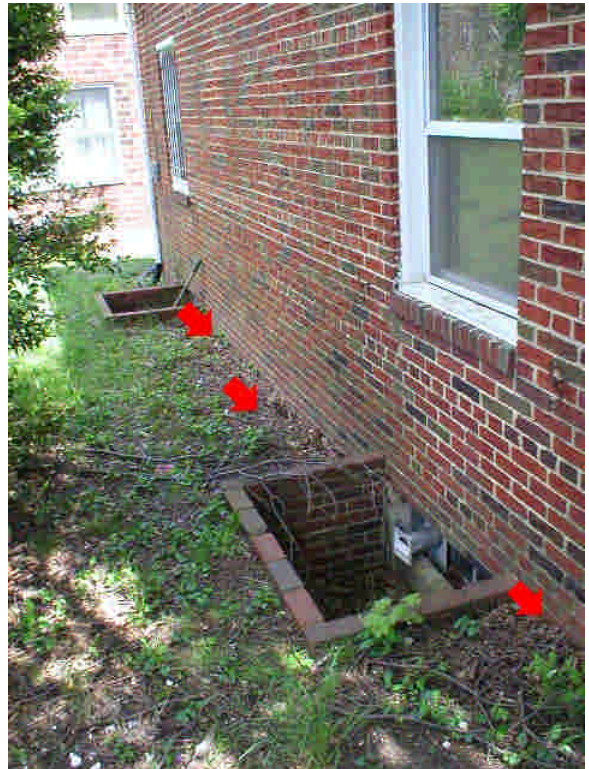
The grades are generally satisfactory but there are some low areas. Ideally you should try to develop a slope in the ground directly around the house of 1 inch per foot for a distance of 6 feet with a clear continuous path for the water from there on. The grade is low along the rear of the house. The grade is low along the right side of the house. Failure to achieve proper grade around the foundation walls is one of the leading causes of basement water problems. It is recommended that you hire a qualified landscaper to correct any low areas or cavities found so that surface water runs away from the house.

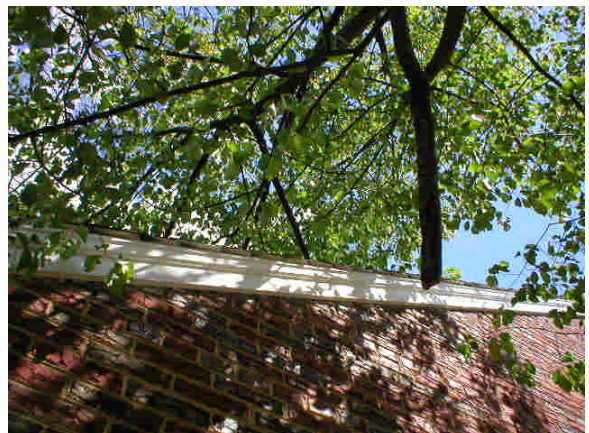
Limbs touching the roof, should be cut back. Damage is possible.

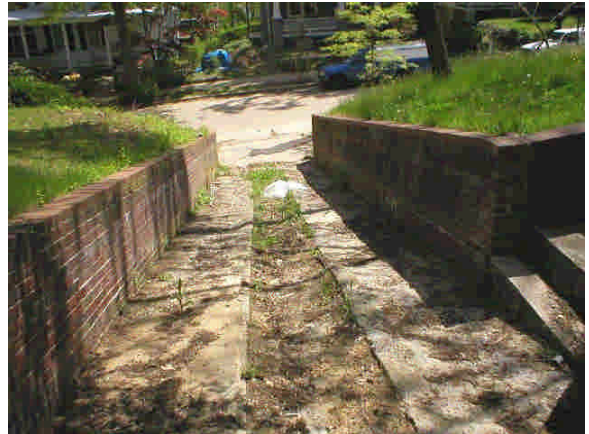
NO, AREA SUPPORTED: The yard along the edge of the driveway.

Brick. Stone. **CONDITION:** Satisfactory; not in perfect condition but not in danger of failure any time soon. Needs backfill behind the walls to reduce the hydrostatic pressure against the wall.

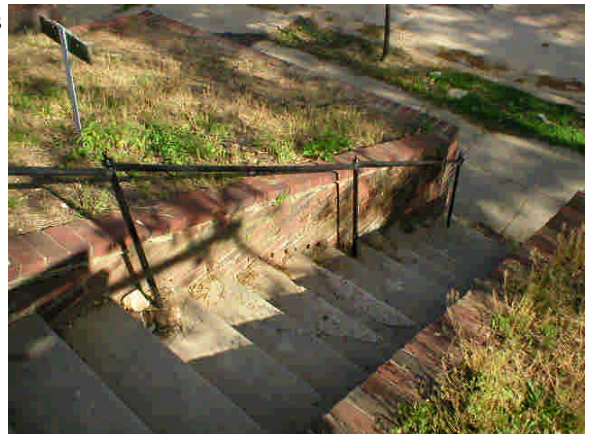
Satisfactory. The concrete has been spalling. Patching repairs are not permanent but will forestall total replacement. The repairs made may not hold but will forestall more extensive repair.

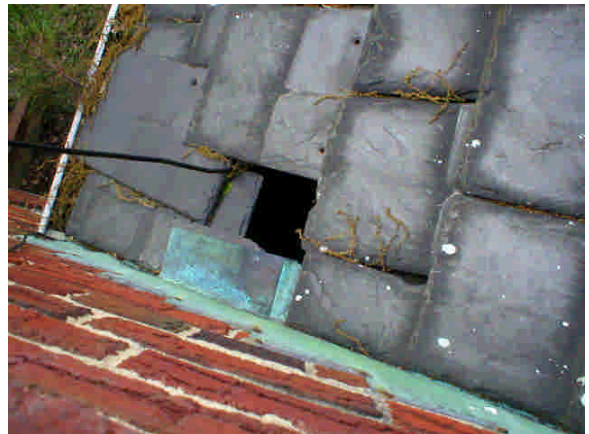
Generally satisfactory but it does need some remedial work.  
Specifics conditions observed : A lot of shingles are missing and or broken.

Have a qualified roofer evaluate it and repair as needed. The roof should last at least 10 more years if correctly maintained.

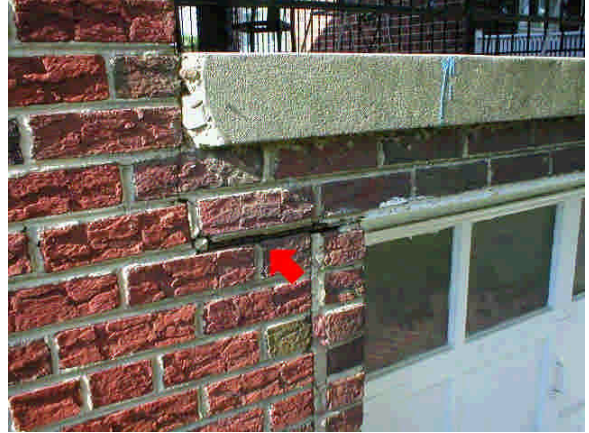
Some masonry wear was noted. The steel lintels have rusted and expanded opening a crack. An effort is needed to prevent further expansion.

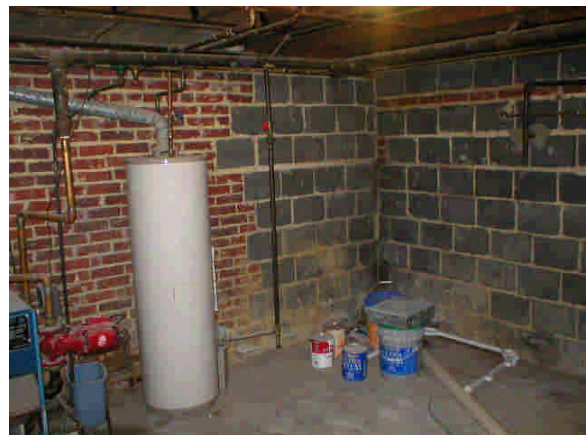
Satisfactory. No evidence of any significant distress. Cracks were noted but were not considered structurally threatening.

PRIMARY FOUNDATION WALL: Brick. Block.

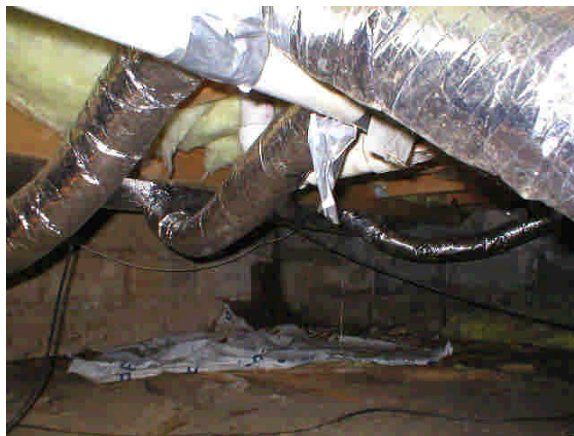
The crawlspace is wet and insulation is falling. It needs to be cleaned out, dried out, and a vapor barrier put down.

VAPOR BARRIER: Put 6 mil plastic on the ground with overlapping joints and weigh down the edges.

VENTILATION: Inadequate. Ventilation modifications are recommended to prevent mold and fungus growth.

INSULATION: Pieces have fallen out and need to be replaced. Recommend reinsulating. Generally perimeter insulation works better than floor insulation.

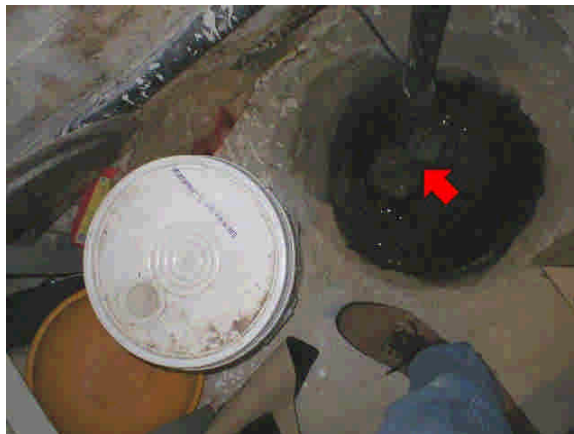
The sump pump does not work correctly. Recommend a plumber come and evaluate components and make repairs as needed.

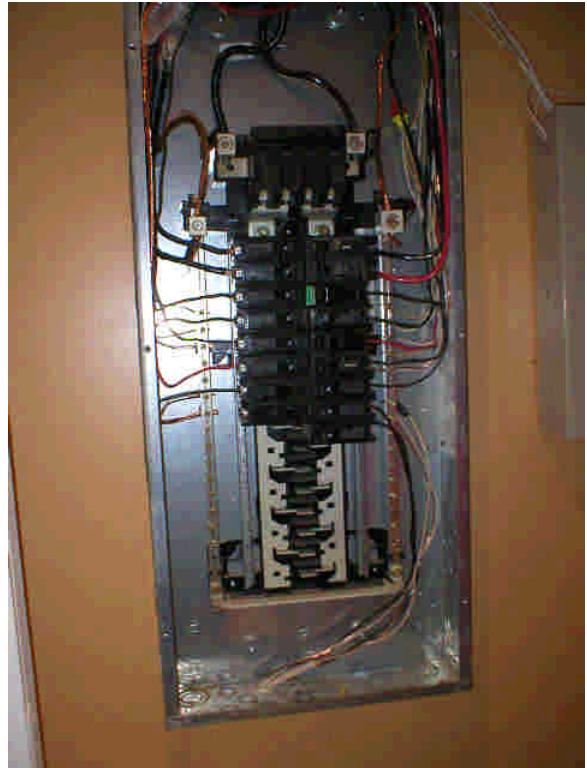
The system is grounded. Satisfactory, No problems found.

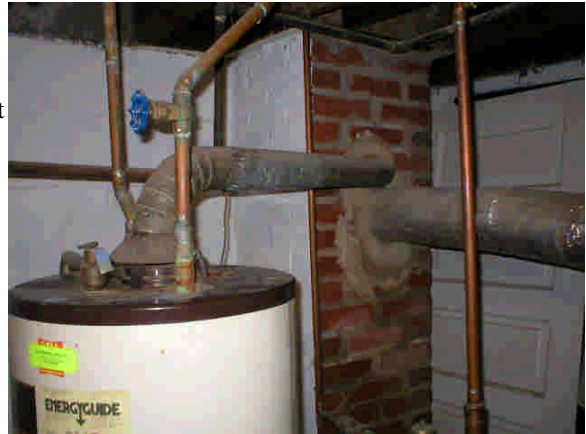
The unit is near the end of its useful life. **GAS WATER HEATER:** The draft hood is not secured correctly. It is too easily knocked loose. The vent does not have the recommended slope on it that is needed to assure good exhaust gas flow. It should slope continuously at 1/4" per foot. A licensed plumber should be called to make further evaluation and repairs as needed.

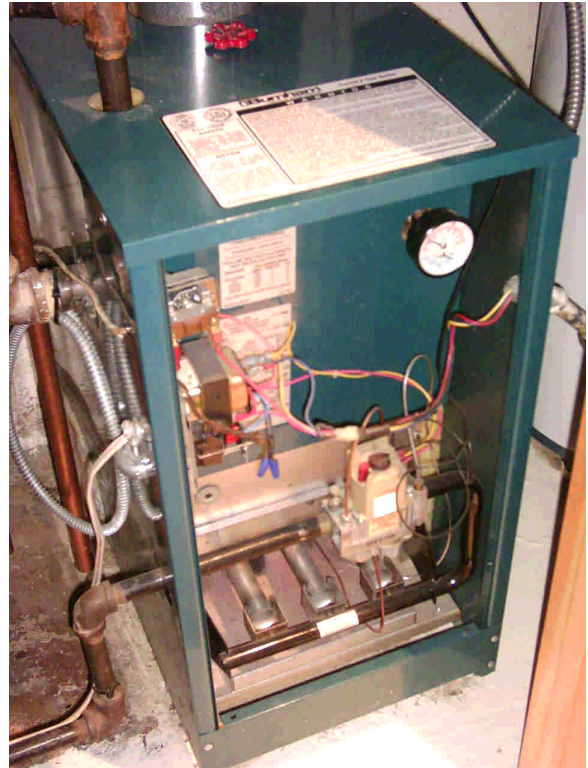
BRAND: Bryant. APPROXIMATE CAPACITY (input):  
100,000 Btuh.

TYPE OF HEAT: Conventional boiler 60-78% efficient. FUEL: Natural gas. DISTRIBUTION METHOD: Forced hot water. Radiators.

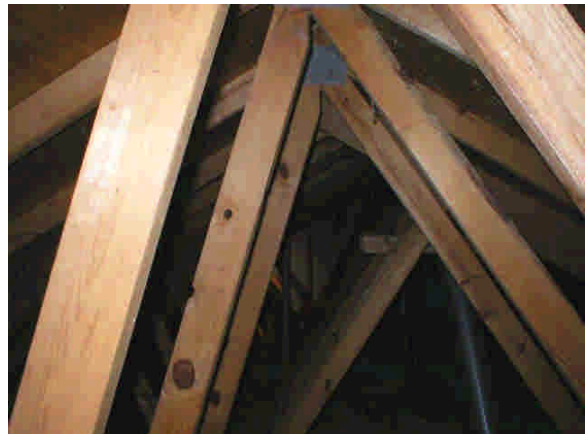
Good. Materials and workmanship are above average.

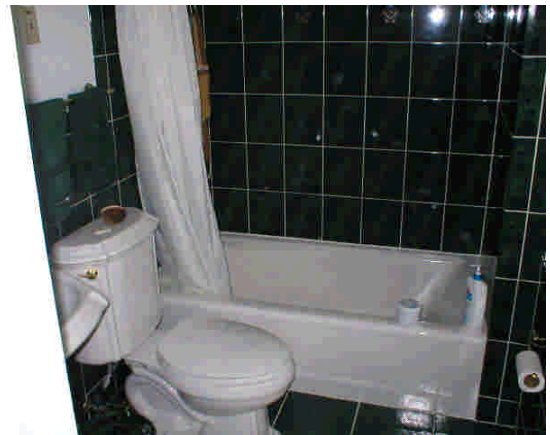
Loose tile was observed that needs to be repaired.

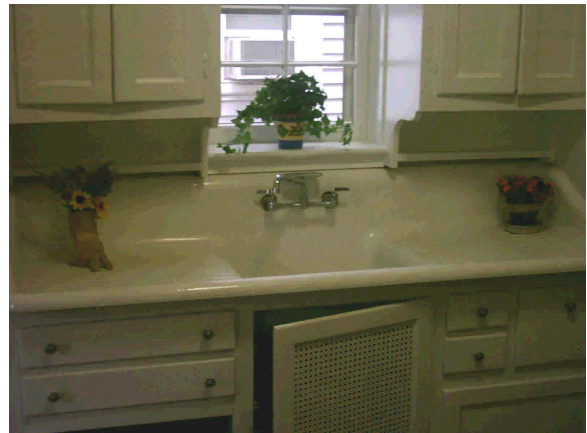
Everything is currently working, the kitchen is functional, but most of the components are at an age that most homeowners would start to consider remodeling for design improvements and increasing frequency of repair.
