# Claxton Walker & Associates

## Property Inspection Report

**Inspection Site:** 1000 Main St.  
Anywhere MD 12345

11/16/2005.

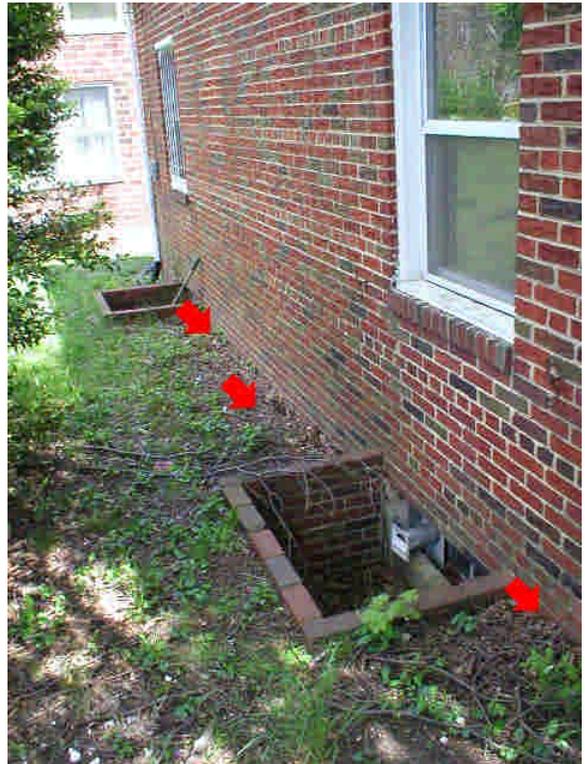
The lot is terraced out of the original slope. Back to front. The back yard doesn't have good run off away from the house.

The grades are generally satisfactory but there are some low areas. Ideally you should try to develop a slope in the ground directly around the house of 1 inch per foot for a distance of 6 feet with a clear continuous path for the water from there on. The grade is low along the rear of the house. The grade is low along the right side of the house. Failure to achieve proper grade around the foundation walls is one of the leading causes of basement water problems. It is recommended that you hire a qualified landscaper to correct any low areas or cavities found so that surface water runs away from the house.

The grades are generally satisfactory but there are some low areas. Ideally you should try to develop a slope in the ground directly around the house of 1 inch per foot for a distance of 6 feet with a clear continuous path for the water from there on. The grade is low along the rear of the house. The grade is low along the right side of the house. Failure to achieve proper grade around the foundation walls is one of the leading causes of basement water problems. It is recommended that you hire a qualified landscaper to correct any low areas or cavities found so that surface water runs away from the house.

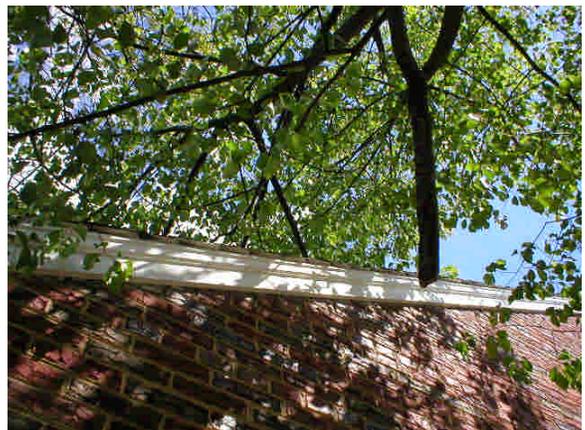
Limbs touching the roof, should be cut back. Damage is possible.

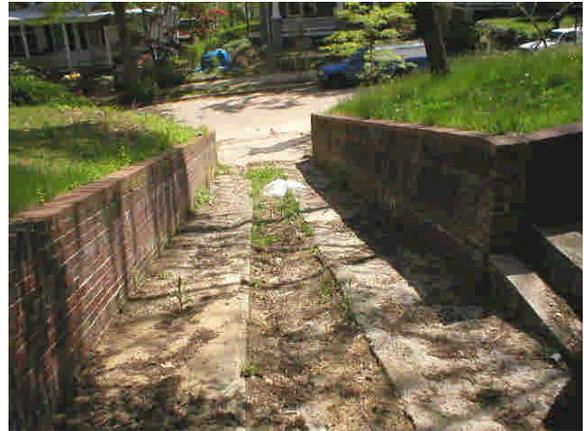
NO, AREA SUPPORTED: The yard along the edge of the driveway.

Brick. Stone. CONDITION: Satisfactory; not in perfect condition but not in danger of failure any time soon. Needs backfill behind the walls to reduce the hydrostatic pressure against the wall.

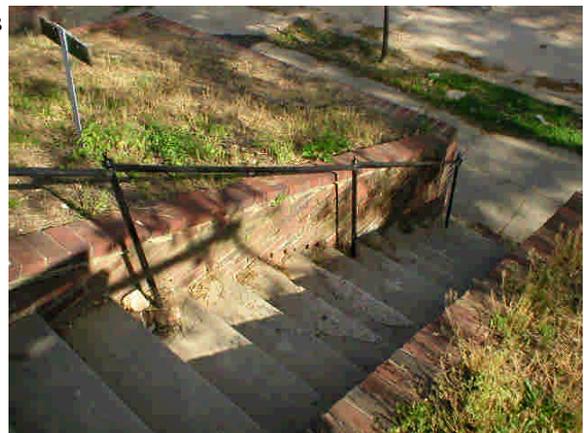
Satisfactory. The concrete has been spalling. Patching repairs are not permanent but will forestall total replacement. The repairs made may not hold but will forestall more extensive repair.

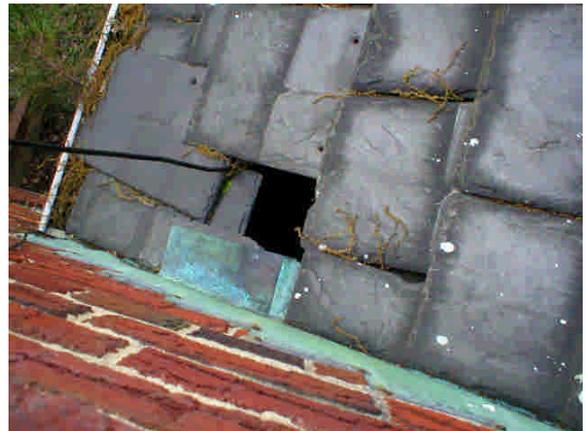
Generally satisfactory but it does need some remedial work.  
Specifics conditions observed : A lot of shingles are missing and or broken.

Have a qualified roofer evaluate it and repair as needed. The roof should last at least 10 more years if correctly maintained.

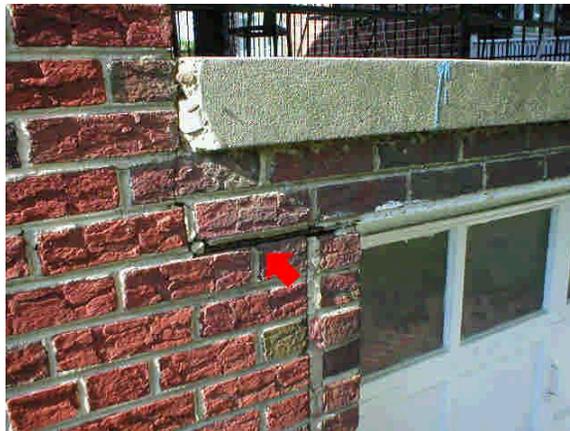
Some masonry wear was noted. The steel lintels have rusted and expanded opening a crack. An effort is needed to prevent further expansion.

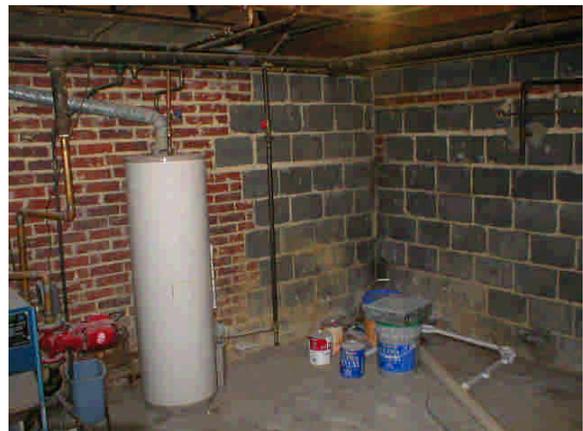
Satisfactory. No evidence of any significant distress. Cracks were noted but were not considered structurally threatening.

PRIMARY FOUNDATION WALL: Brick. Block.

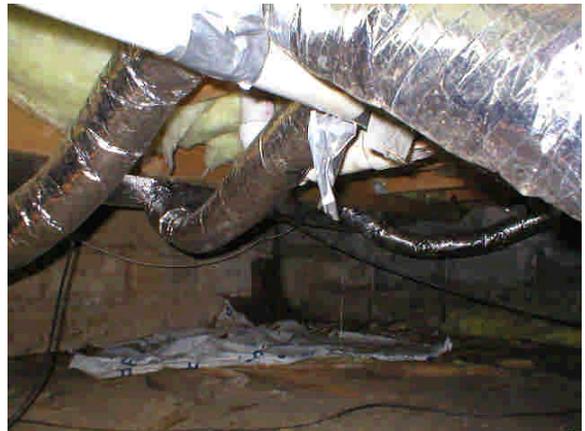
The crawlspace is wet and insulation is falling. It needs to be cleaned out, dried out, and a vapor barrier put down.

VAPOR BARRIER: Put 6 mil plastic on the ground with overlapping joints and weigh down the edges.

VENTILATION: Inadequate. Ventilation modifications are recommended to prevent mold and fungus growth.

INSULATION: Pieces have fallen out and need to be replaced. Recommend reinsulating. Generally perimeter insulation works better than floor insulation.

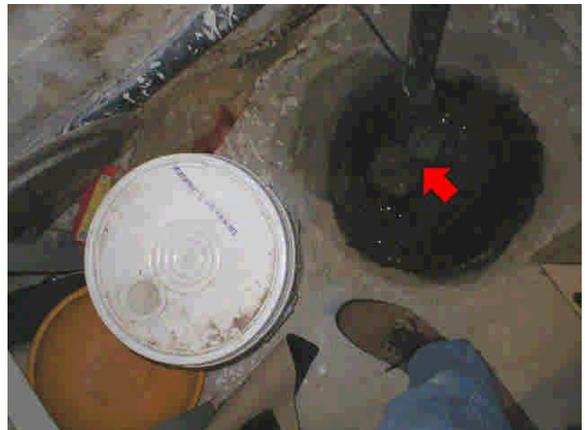
The sump pump does not work correctly. Recommend a plumber come and evaluate components and make repairs as needed.

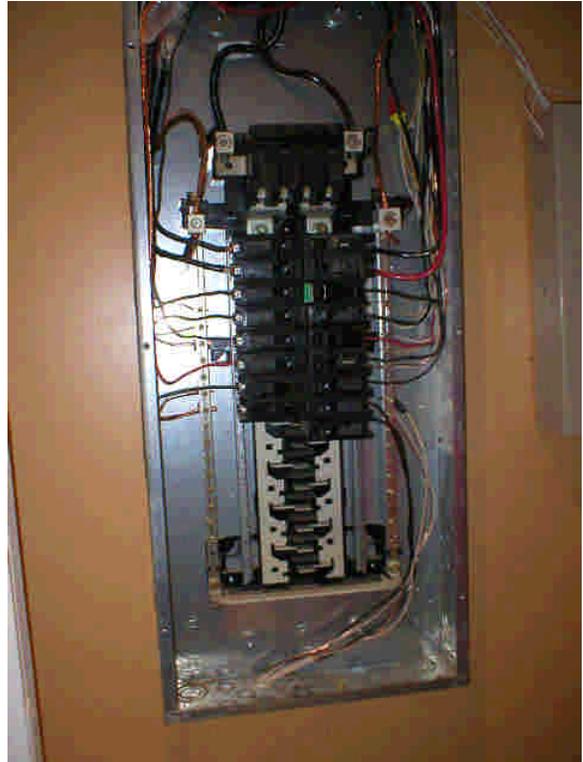
The system is grounded. Satisfactory, No problems found.

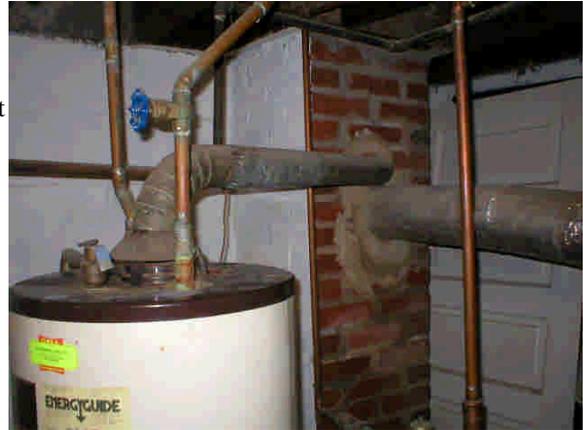
The unit is near the end of its useful life. **GAS WATER HEATER:** The draft hood is not secured correctly. It is too easily knocked loose. The vent does not have the recommended slope on it that is needed to assure good exhaust gas flow. It should slope continuously at 1/4" per foot. A licensed plumber should be called to make further evaluation and repairs as needed.

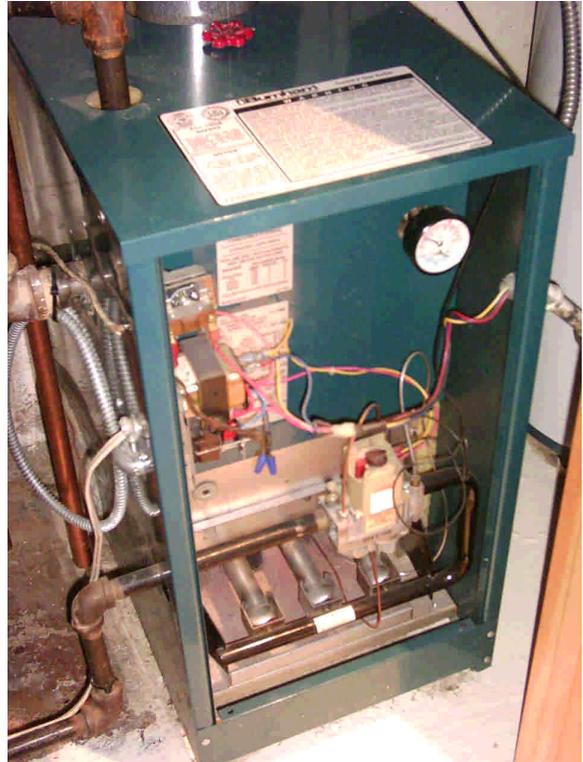
BRAND: Bryant. APPROXIMATE CAPACITY (input):  
100,000 Btuh.

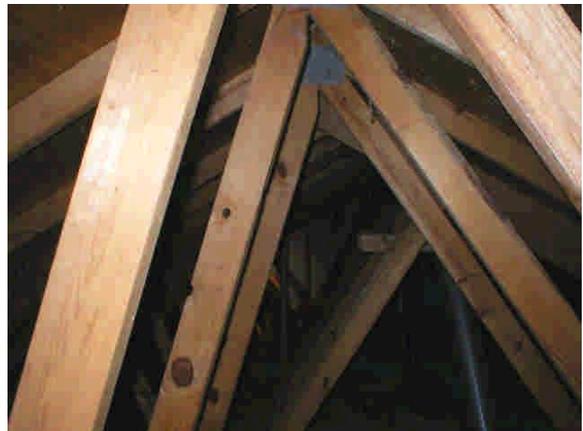
Good. Materials and workmanship are above average.

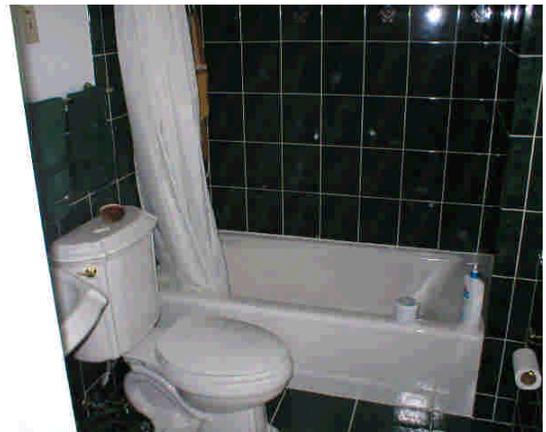
Loose tile was observed that needs to be repaired.

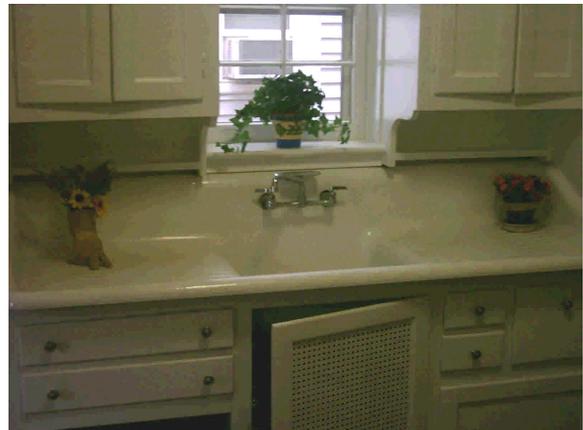
Everything is currently working, the kitchen is functional, but most of the components are at an age that most homeowners would start to consider remodeling for design improvements and increasing frequency of repair.
